FACE INVESTIGATION

SUBJECT: Tree Trimmer Dies When Truck-Mounted Aerial Bucket Arm Collapsed

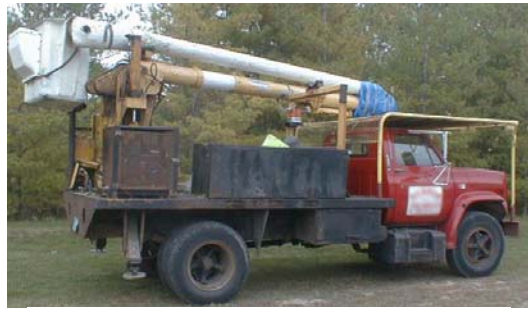
SUMMARY: A male tree trimmer (the victim) died when the boom of a truck-mounted aerial lift collapsed while he was trimming trees from the bucket (Figure 1). The bucket crashed to the ground, after first striking the truck bed. The victim had not been wearing a safety harness with lanyard at the time the boom collapsed, and he was thrown from the bucket. A co-worker was clearing brush in the vicinity of the truck at the time of the incident when he heard a sound and turned toward the truck. He saw the bucket crash to the ground, with the victim falling from the bucket after it struck the truck. The co-worker used a cell phone to call for emergency services. EMS services arrived and observed the victim was breathing. He was transported to the hospital, where he was pronounced dead. The FACE investigator concluded that, to prevent similar occurrences, employers should :

Figure 1. Photo of the truck and aerial lift involved in incident.

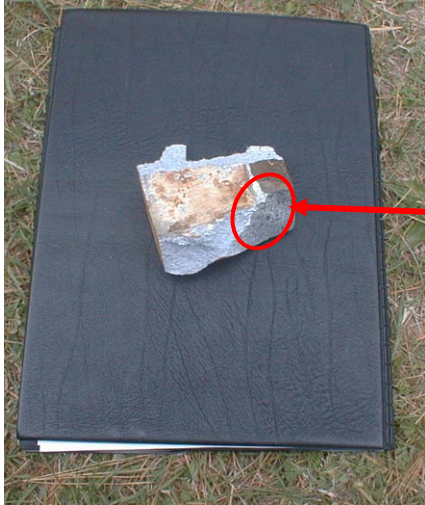
While searching the scene, police discovered a portion of a metal casting in the grass under where the boom had been elevated (Figure 2). The piece had broken off a bracket surrounding a hydraulic cylinder that had held the cables to support the boom.

Figure 2. Broken metal casting from boom support. Discolored area matches area on broken support bracket (Figure 3).

Recommendation #2. Visually inspect metal parts of booms that bear heavy loads to detect cracks in metal or other signs of damage.

Discussion: In this instance, it could not be determined whether or not a pre-existing crack was present when the incident occurred. If a crack did exist on the bracket, it may have been detectable by a visual inspection of the boom; daily visual inspections and maintenance checks to identify potential hazards should be performed prior to placing machinery into operation. Additionally, the employer might consider employing a method to test for metal cracks that involves placing an electric charge on the parts, then applying a dust material that collects in the cracks and makes them visible. While this method of testing might be economically unfeasible to perform on a regular basis, it could be performed annually or biannually. The test was not done as part of the annual inspection completed by the inspection company.

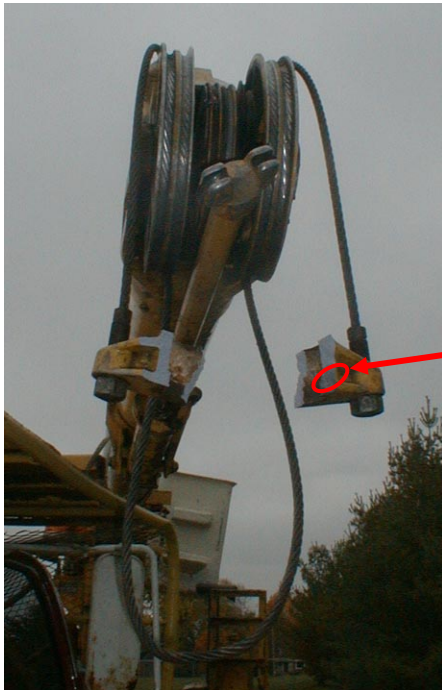
The piece of support bracket that had broken off, and the two sides of the remaining support bracket showed an area of discoloration that may indicate the location of a pre-cracked and weakened area of the casting (Figure 3).

Figure 3. Discolored area on bracket.
